# 33 PRESERVATION BRIEFS

## The Preservation and Repair of Historic Stained and Leaded Glass

Neal A. Vogel and Rolf Achilles

National Park Service  
U.S. Department of the Interior

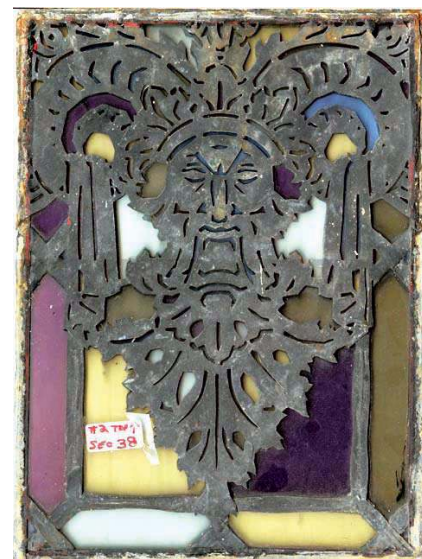
Figure 10. This lead-silhouette stained glass face graces a 1928 coach house in Buffalo, and is attributed to D'Ascenzo Studios of Philadelphia.

Some creative efforts expanded leaded glass media in new directions. Lead-overlay or “silhouette” glass was one novelty that climaxed in the late 1920s and early 1930s. Some designers sandwiched glass between layers of hand-cut sheet lead, while others sandwiched the perforated sheet lead between layers of glass. These windows present a playful reversal from traditional stained glass; in “silhouette” glass the lead metalwork, rather than the glass, becomes the primary art form (Fig. 10). However, such novelties failed to catch on during the Depression. World War II delivered the final blow and ornamental glass is seldom found in residential, commercial, and secular architecture after circa 1940. The great age of American stained glass was over. Fortunately, leaded glass panels survived in uncounted numbers throughout the country, and are now once again appreciated as virtually irreplaceable features of historic buildings.

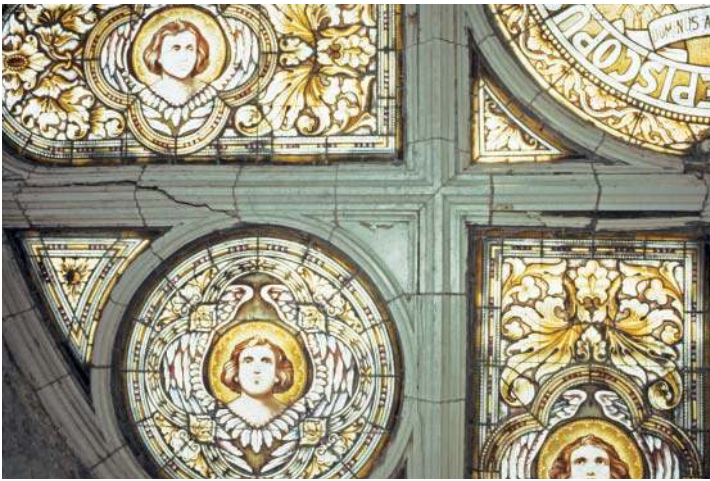
Figure 12. Stained glass frames are typically wood, steel or stone; however, other materials, and their inherent problems, can also be found as seen in this photograph of cracked terra cotta frames from 1926.

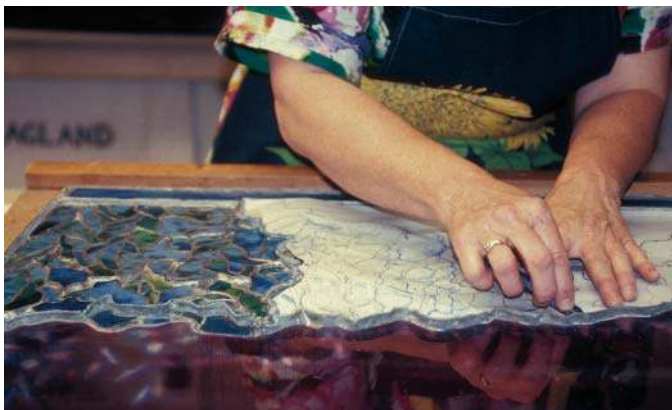
*Figure 14. The external glass plate has been removed to clean the interlayer of this plated Tiffany Studios window.*

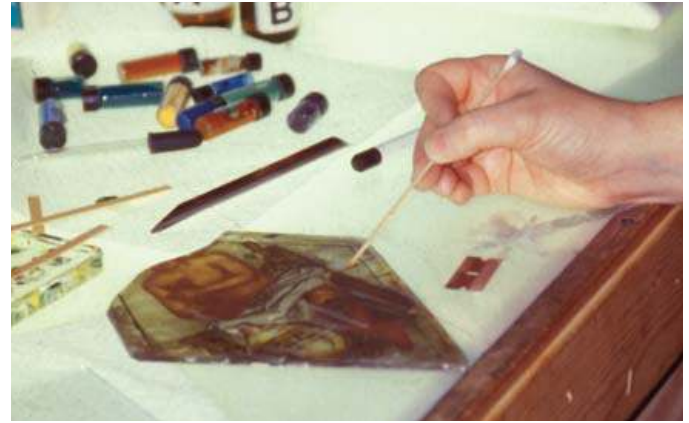
Figure 16. A valuable historic piece of original hand-painted glass is carefully edge-glued with epoxy.

**Epoxy Edge-Gluing:** This technique produces a nearly invisible line and is often used on painted glass, particularly focal points of a window such as a face, or a portion of sky intended to be one continuous piece. Epoxy can even be tinted to match the glass. It is also used for infusing shattered glass or microscopic cracks caused by intense heat from a fire. Epoxy produces a very strong repair, but will deteriorate in sunlight and requires secondary glazing to protect it from UV degradation. Epoxy is the least reversible of the three techniques, and usually the most expensive.

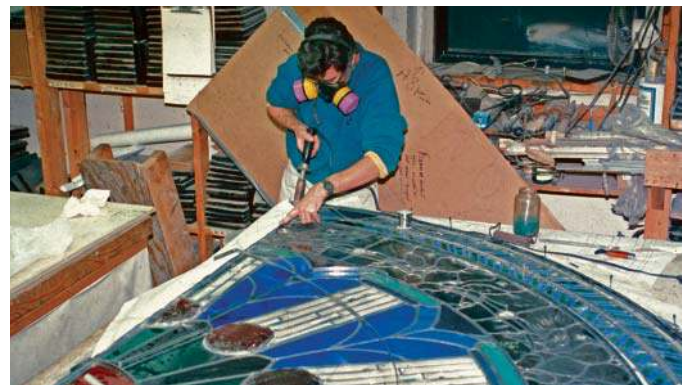
*Figure 17. Total releading is very time consuming and costly and should only be undertaken when the original lead is exhausted beyond repair.*

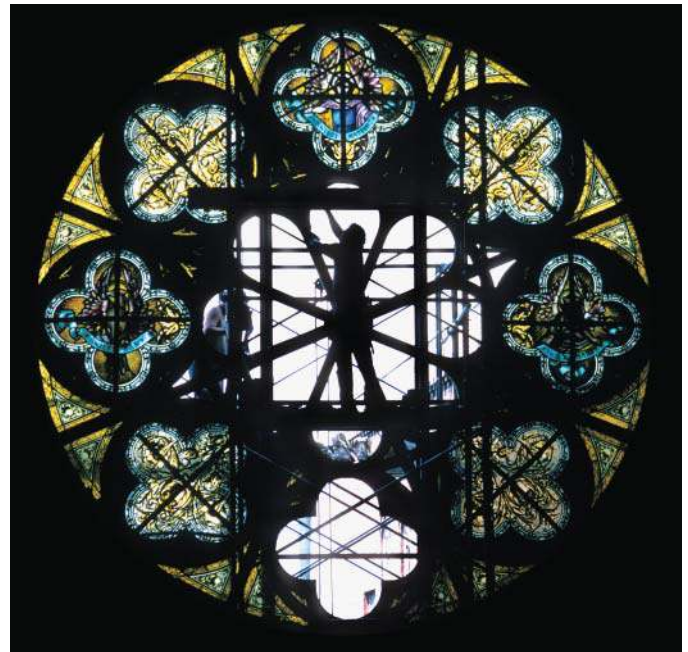
Wooden frame of the rose window undergoing repair (exterior view).
