## O'BRIEN STAINED GLASS CO., INC.

### STAINED GLASS RESTORATION

St. Mary's, Sleepy Eye, MN

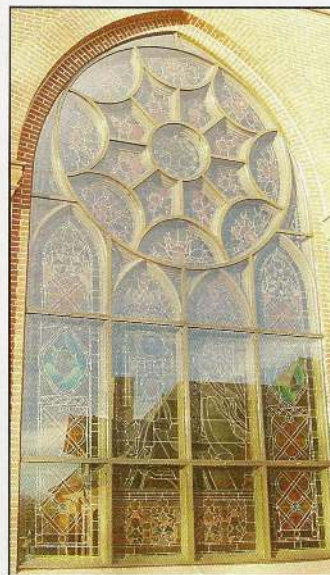
**After**

The lattice work of four Gothic lancets rise up shoulder to shoulder to cradle the rose window with the eight pointed star.

The picture on the right shows the rebuilt stained glass window with all woodwork preserved and protected. The "brick to brick" 1/4" clear storm glass protects it all.

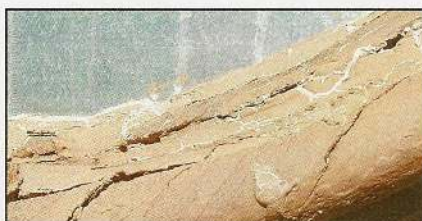
To the left is a view of some of the woodwork that was in the most deteriorized condition (1/3 actual size).

The old storm covering was removed. The wood frame received extensive preparation, reinforcement, and repair before applying two coats of Sherwin Williams Duration latex paint.

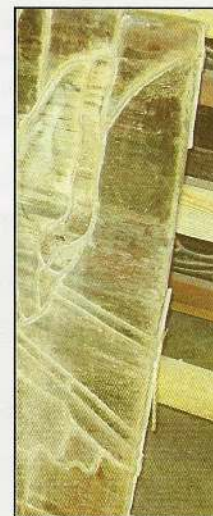
At right is a closeup view of one of the panels. It has been removed from the frame and brought to the shop to be taken apart, cleaned, and rebuilt with new lead. The accumulation of dust and streaking that was hidden behind the storm glass is now very plain. The effects of exposure and corrosion can be seen in the broken border lead at the bottom of the window.

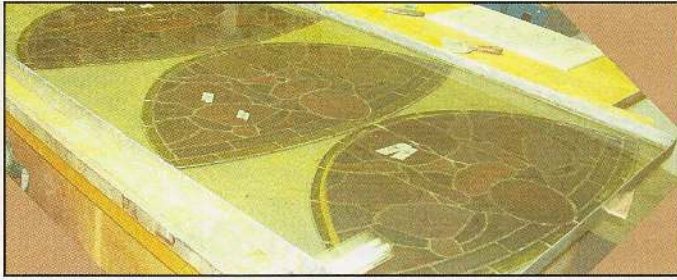
At left, big soaking pans hold the petals from the outer portion of the rose window. The windows are soaked in shallow metal pans prior to disassembly. The soaking loosens the dirt and grime on the window surface. Soaking in water softens the putty and makes it easier to take the window apart.

By keeping the window underwater as it is being taken apart, lead contamination is kept to a minimum. Lead is recycled.

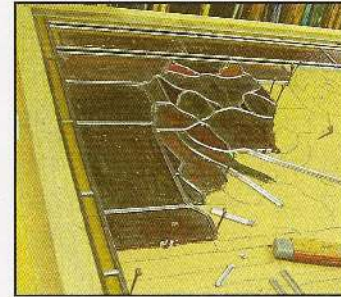
At right - A pattern for the construction of the window is created by placing craft paper and carbon paper atop the original stained glass panel and rubbing the impression onto the paper prior to disassembly. After the glass pieces are cleaned and set aside, they are reassembled along with any repair glass that may be needed. The lead channeling is cut and trimmed to hold all of the pieces of glass. The joining sections of lead are then soldered together.

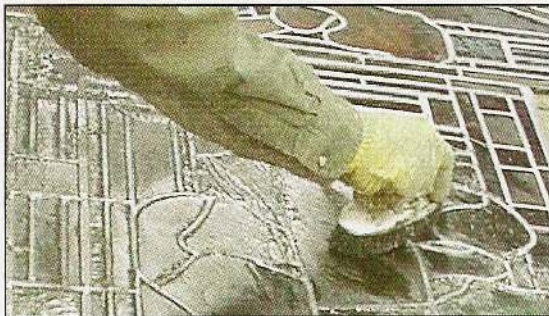
The picture below shows the liquid cement (also called grout) being applied to one side of the window. The excess grout is removed and the window is polished to a high shine. After the cement has hardened the panel is turned and the waterproofing is applied to the other side. Much of the strength of a stained glass window is derived from the cement which fills in all the gaps and spaces between the lead and the glass.

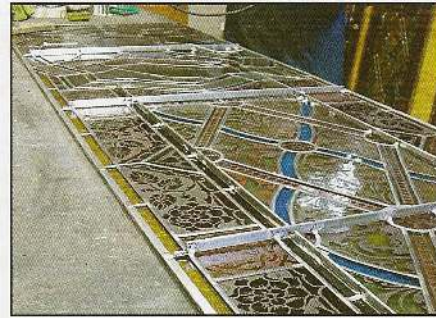
Above - The art of "box bracing" means that stained glass windows last far longer by providing vertical and horizontal support. Many shops that charge more do not provide this service.
